INDOOR AIR QUALITY ASSESSMENT

**Berkshire Community College
Jonathan Edwards Library
1350 West Street
Pittsfield, Massachusetts**

Prepared by:
Massachusetts Department of Public Health
Bureau of Environmental Health
Indoor Air Quality Program
November 2016

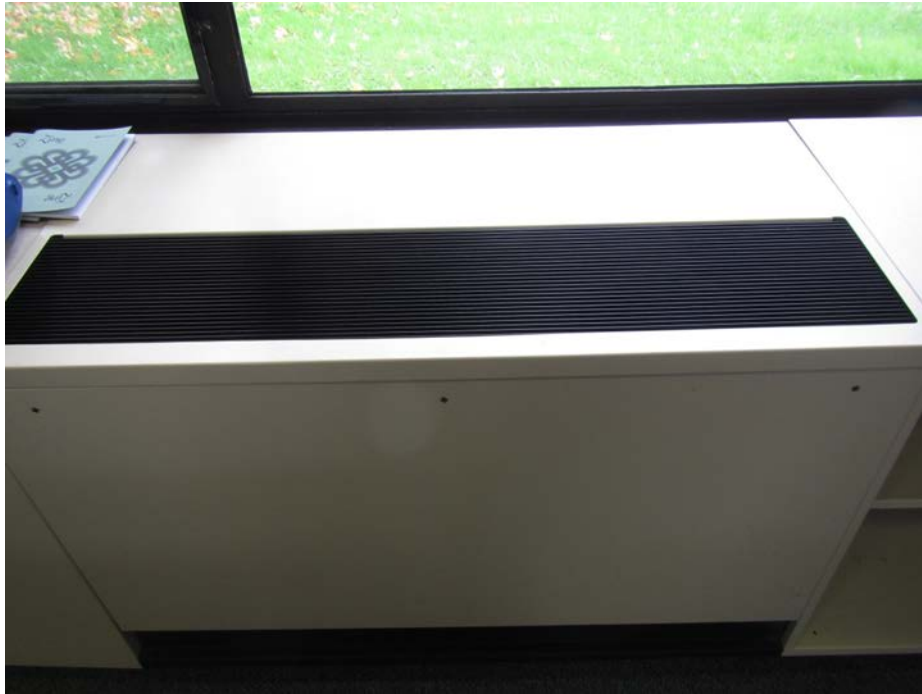
Picture 1

The HVAC system at the JEL consists of unit ventilators (univents) and some perimeter radiator units. The unit ventilators draw fresh air through a vent on the exterior wall (Pictures 1 and 2). Air is mixed with return air from the room, filtered, heated (if needed) and delivered back to the room ([Figure 1](#)). The unit ventilator units at the JEL do not provide air conditioning (AC). A window AC unit exists that is intended to cool an enclosed office space behind the circulation desk (Picture 3).

Unit ventilator

1. Operate all unit ventilators continuously during occupied hours and supplement fresh air with open windows as needed. Continue to clean and maintain these units regularly including filter changes per manufacturer recommendations.

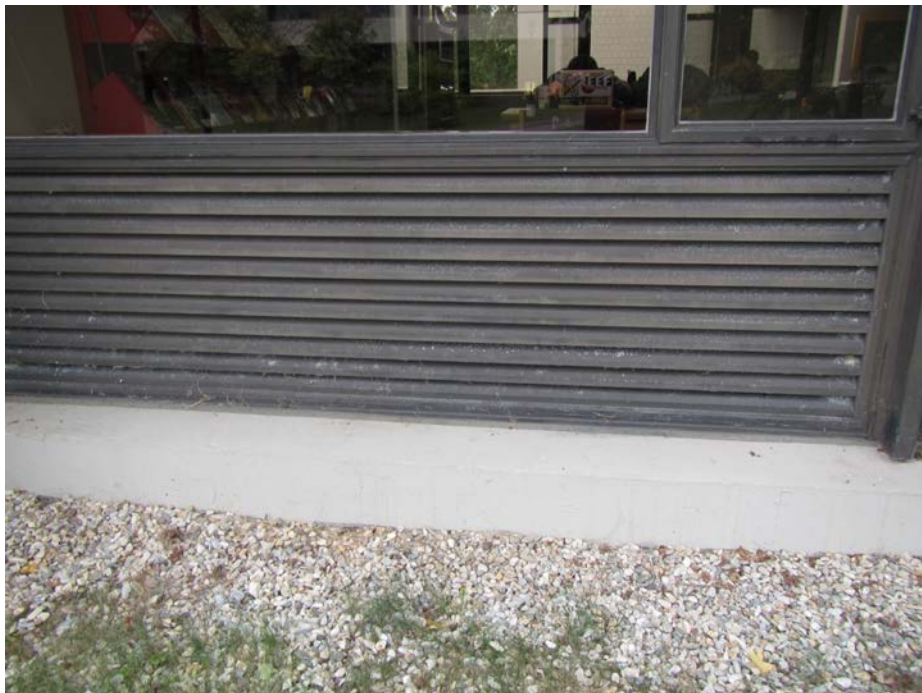
Picture 2

Fresh air intake for unit ventilator

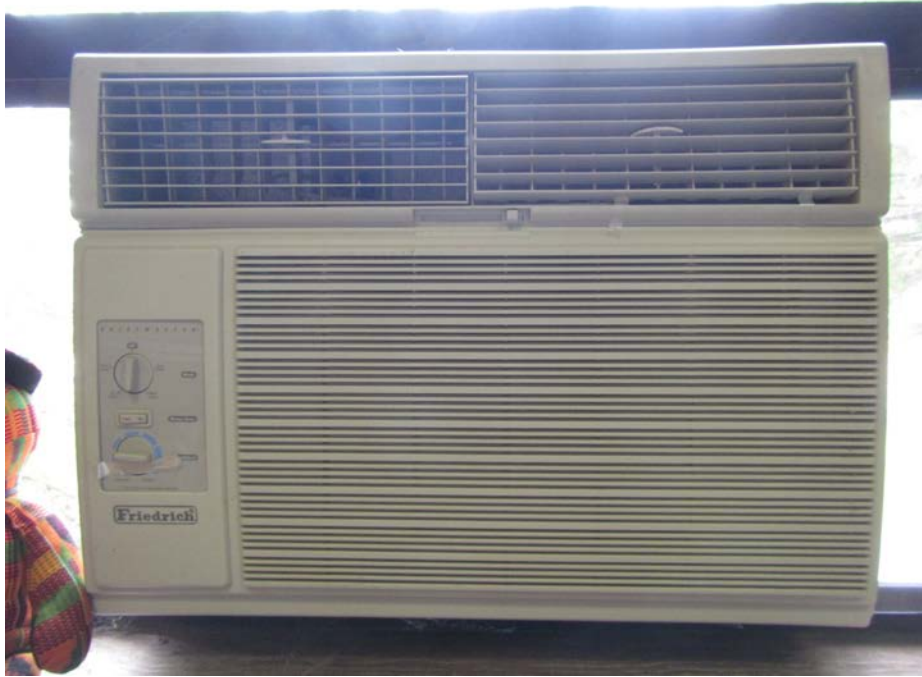
Picture 3

The window AC unit appears to be sized to only serve the office area behind the circulation desk. In general, AC units should never run in cooling mode while windows or doors are opened due to the possibility of moisture collecting on surfaces cooled below the dew point. The door to the circulation office (Room E103) should remain closed while operating the AC in this room. The JEL is a very large space that, as stated earlier, does not have building-wide cooling so that leaving this door open while the AC unit is operating would similarly increase the potential of condensation due to the large volume of unconditioned air in the JEL.

Window AC unit in office E103

7. The door to the circulation office (Room E103) should remain closed while operating the AC in this room to avoid condensation from the large volume of unconditioned air. Regularly maintain/clean this AC unit according to manufacturer recommendations.

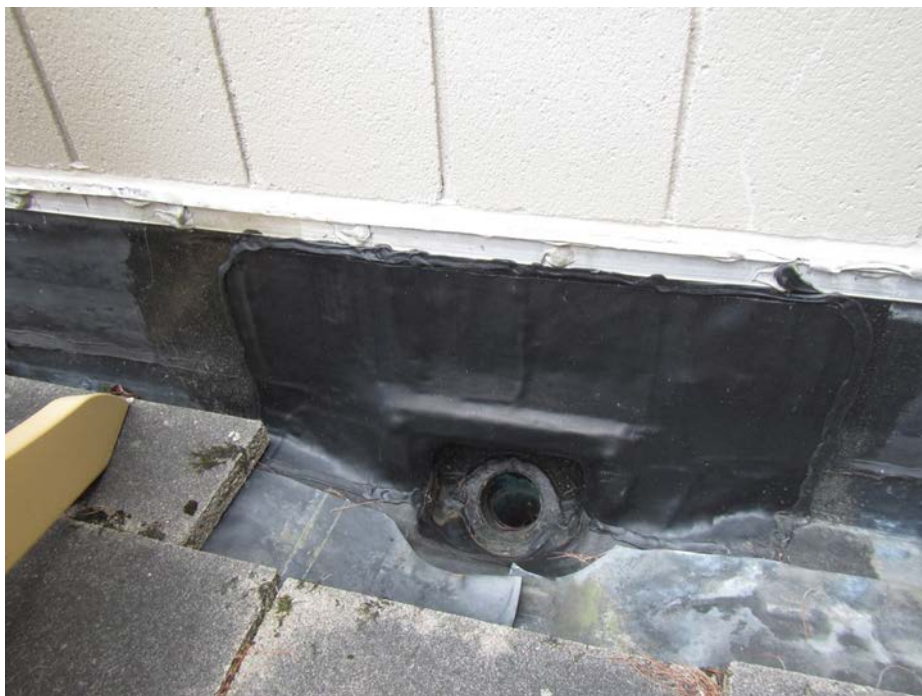
Picture 4

JEL staff reported that the deck/patio off of the main floor of the library experienced water infiltration at the interface of the patio surface and exterior wall of the reference area (Picture 4, Figure 2). The carpet in the reference area was reportedly wet occasionally by this leaking. BEH staff observed an older red section of carpeting which may indicate that furniture or shelving was once installed over it (Picture 5). JEL staff reported that fans were used to dry

the carpet whenever leaks penetrated this area but the red section of carpeting may have been covered and prevented drying by the fans and should be replaced. This leak was eliminated by repairing the rubber membrane beneath the patio blocks. A slight musty odor was detected in the basement area below this leak which may indicate carpeting was chronically moistened.

Patio area showing repairs made to rubber membrane where leaks occurred

4. Continue to monitor the area off of the patio that was previously leaking and take any necessary actions (e.g., fans, further repairs).
5. Any water-damaged porous materials (e.g., carpeting, acoustic ceiling tiles, etc.) not dried within 48 hours should be discarded and replaced to avoid microbial colonization.

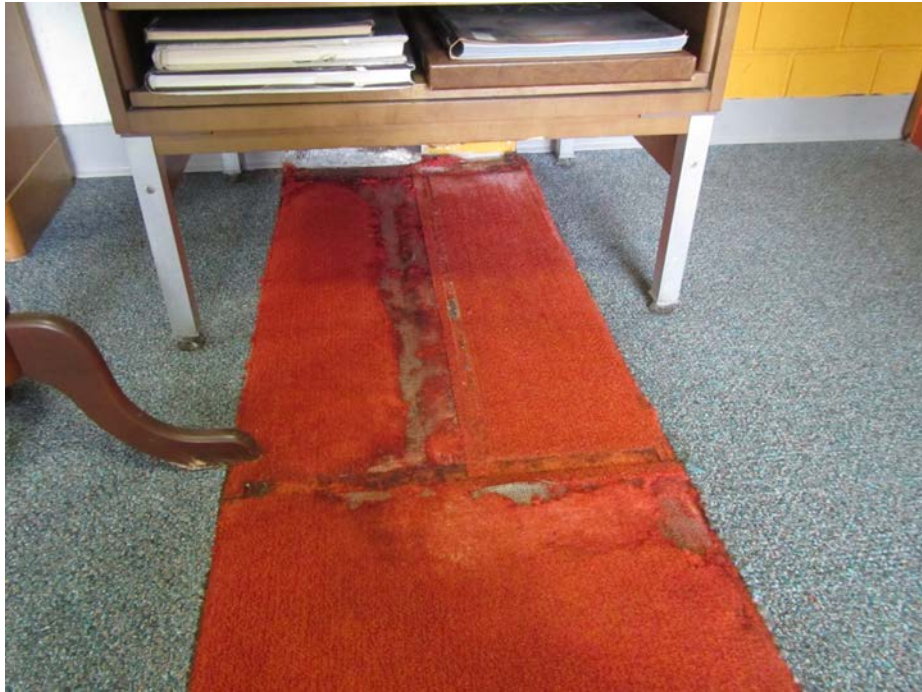
Picture 5

Older red carpeting in area of patio water intrusion

Any water-damaged porous materials (e.g., carpeting, ceiling tiles) not dried within 48 hours should be discarded and replaced to avoid microbial colonization. Typically, carpeting is not recommended in below grade space. Mold resistant carpet tiles should be considered when replacing carpeting in below grade spaces.

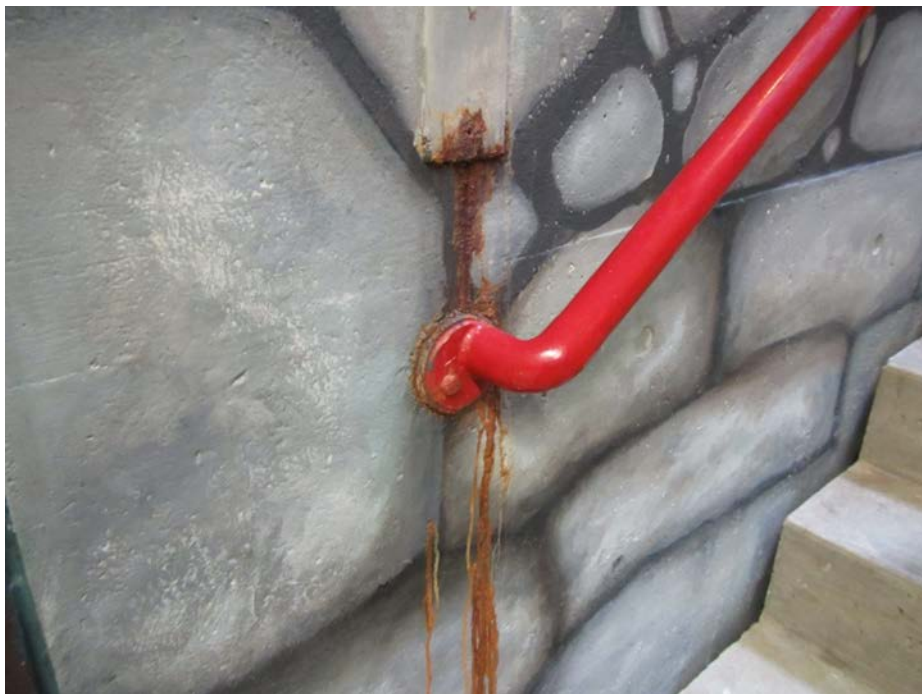
Picture 6

JEL staff reported several areas of water infiltration through the concrete foundation in below-grade areas (Picture 6). It is important to note that concrete is unlikely to support mold growth even when exposed to periodic water leaks. BEH staff did note accumulations of powdery, white material in some areas (Pictures 7 and 8). The white material is called efflorescence; efflorescence is a characteristic sign of water damage to building materials such as brick, mortar, or plaster, but it is not mold growth. As moisture penetrates and works its way through mortar around brick, water-soluble compounds dissolve, creating a solution. As the solution moves to the surface of the brick or mortar, water evaporates, leaving behind white, powdery mineral deposits. This condition indicates that water from the exterior has penetrated into the building. Although concrete does not typically support mold growth, paint, items, or debris near the walls that are moistened may become mold-colonized. When present, efflorescence can be readily cleaned. According to BCC Facilities staff, they have been working to mitigate water infiltration in these areas.

Area of active water infiltration in stairwell

2. Make any necessary repairs to unit ventilator in room E10 (E11 temporary sign).
3. Continue to mitigate any area of active water infiltration through the building envelope.

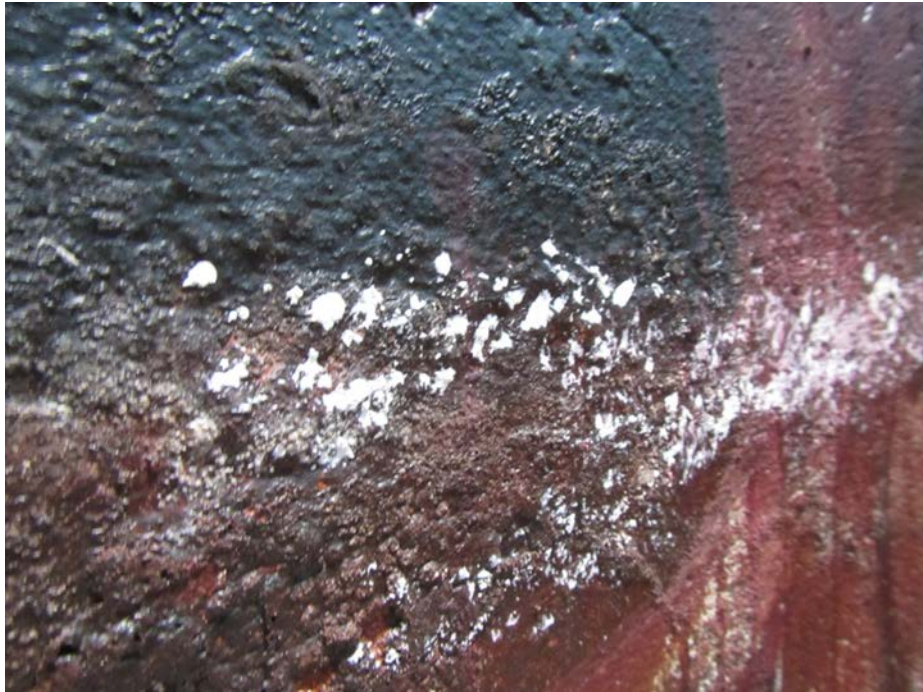
Picture 7

Efflorescence in stairwell

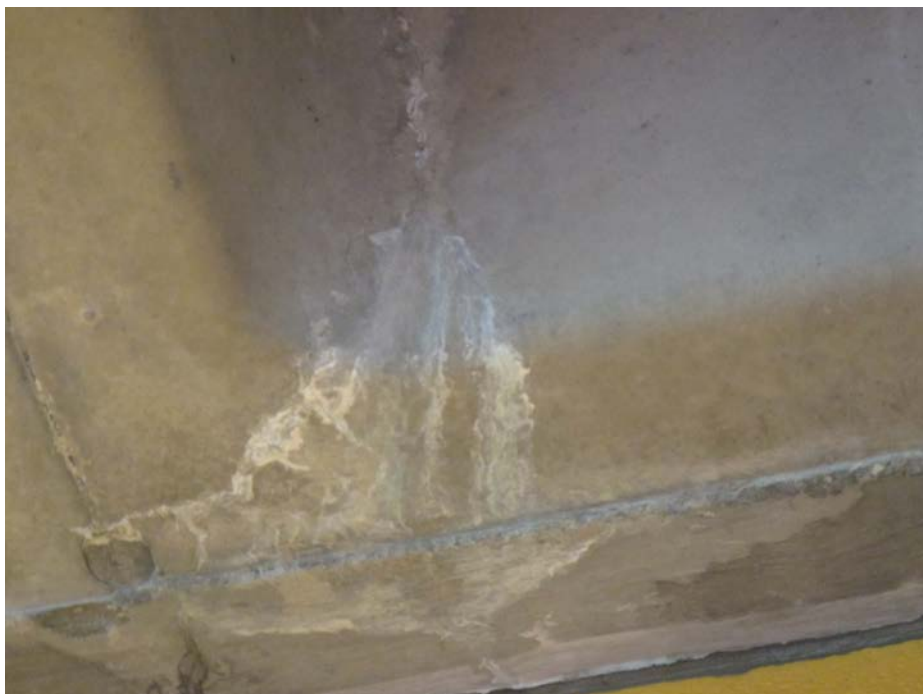
Picture 8

Efflorescence in concrete

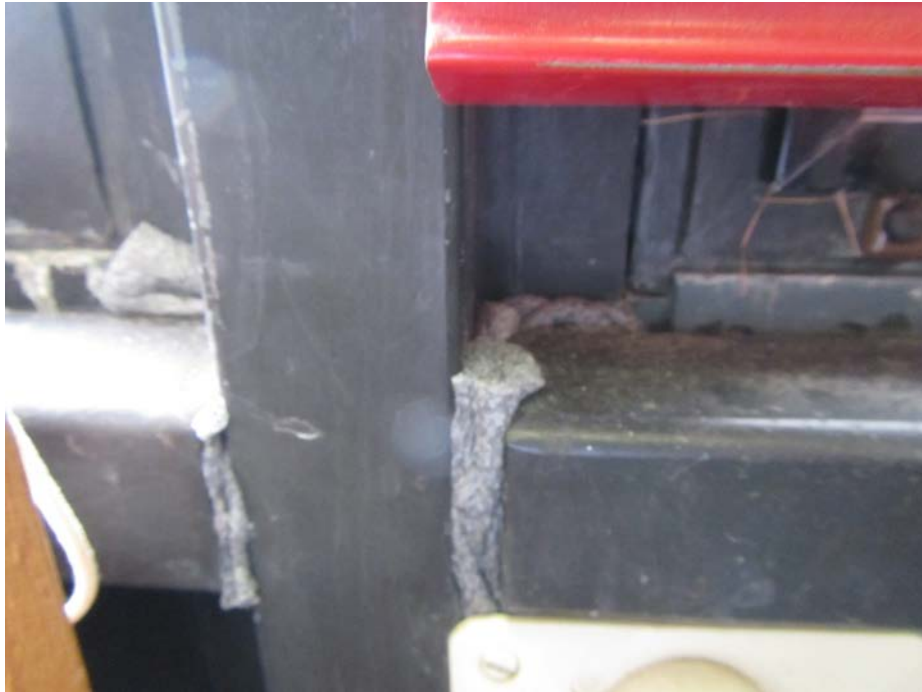
Picture 9

JEL occupants reported that water infiltrates through the older, single pane windows especially during driving rains in areas such as Reference and the Reference office (Picture 9).

Reference area showing older windows where leaks occur

1. Consider installing building-wide cooling for the JEL to more effectively control comfort and humidity.
2. Replace any carpeting beyond its service life. Consider mold resistant carpet squares for new flooring.
3. Consider upgrading the older single pane windows at the JEL to new, energy efficient windows that will eliminate water infiltration and improve comfort for occupants.

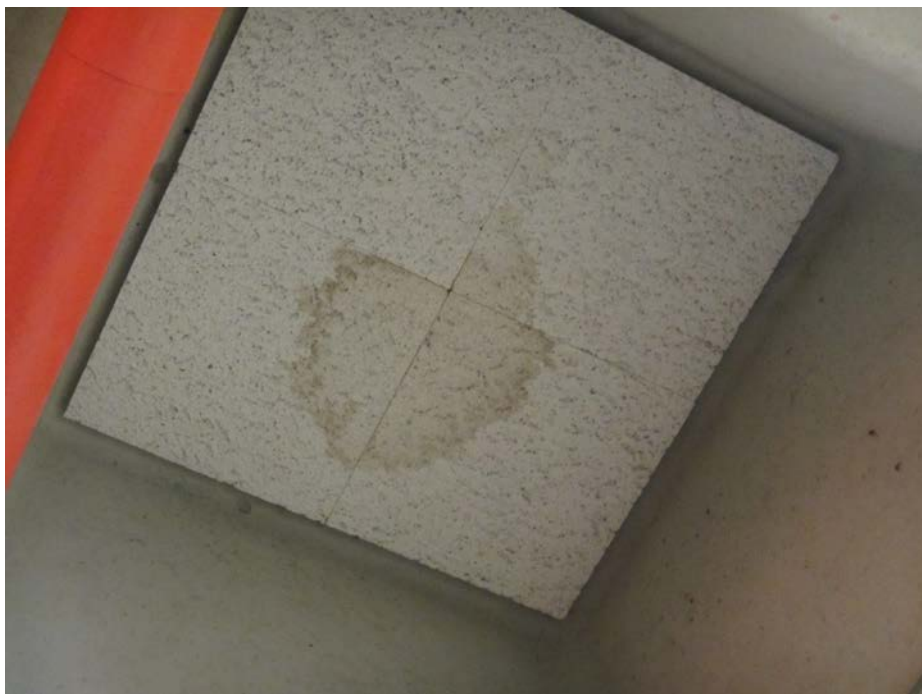
Picture 10

The JEL has acoustic ceiling tiles in some areas to dampen sound in the concrete space. Some of these tiles were noted to be water-damaged (Picture 10). As with carpeting and other porous water-damaged items, any water-damaged acoustic ceiling tiles should be discarded and replaced.

Water-damaged ceiling tiles

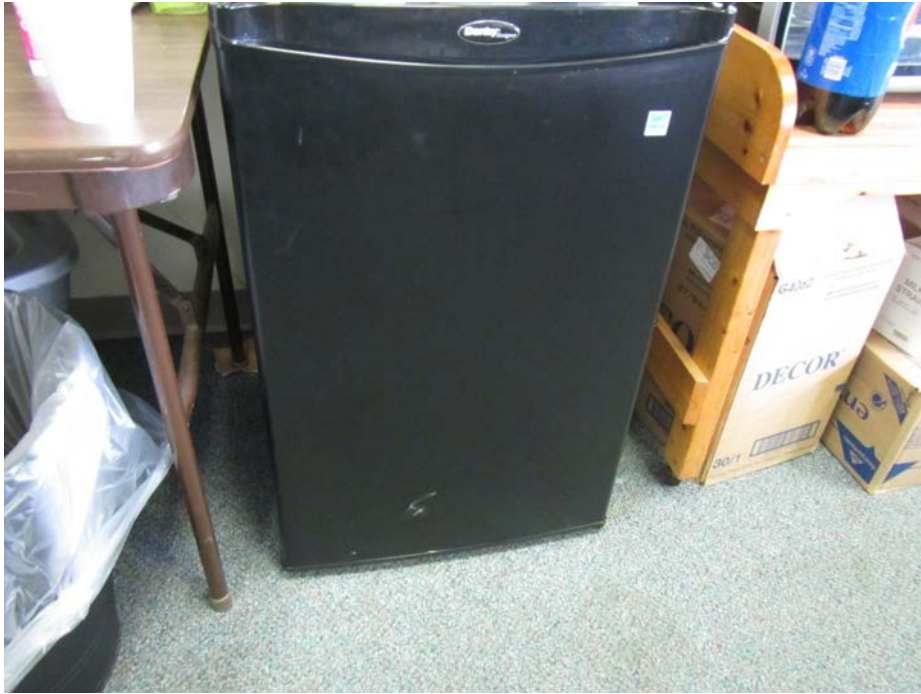
Picture 11

Refrigerators and water coolers/fountains were noted to be placed over carpeting (Picture 11). Chronic leaks or spills from these items can cause carpet degradation and microbial colonization.

Refrigerator placed on carpeting

10. Ensure that procedures are in place and encourage occupants to report HVAC/maintenance issues so that they can be logged and repaired promptly.
11. Consider placing waterproof mats under water fountains/coolers and refrigerators to prevent chronic water damage to carpeting.

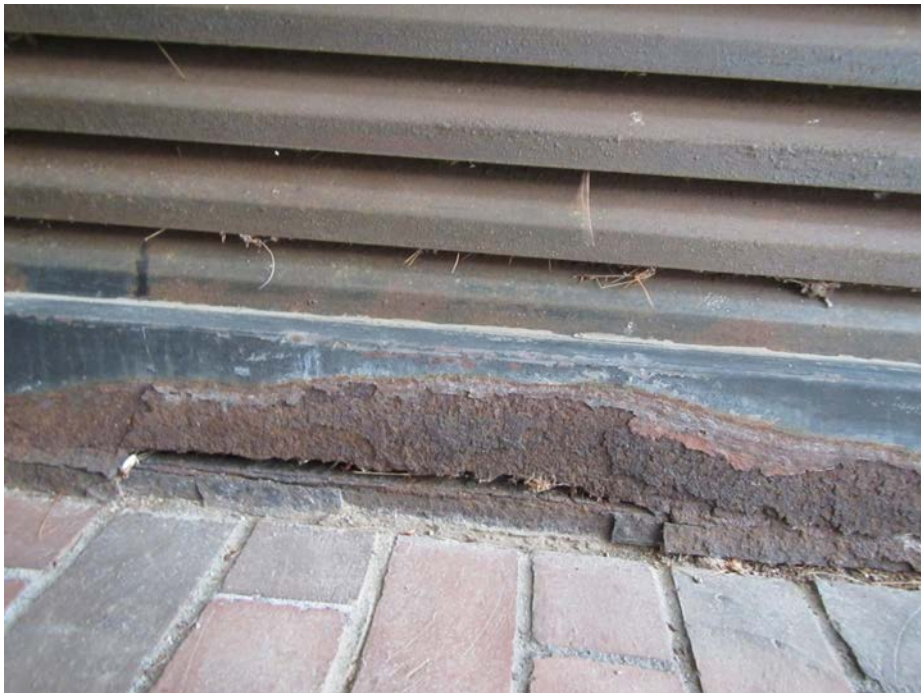
Picture 12

A metal fresh air intake vent cover was noted to be badly corroded outside of the entrance to the JEL (Picture 12). This vent cover should be repaired/replaced to avoid any pests from nesting inside the wall/univent cavity.

Badly corroded fresh air intake vent cover

8. Repair/replace fresh air intake vent cover near JEL entrance to avoid any pests from nesting inside the wall/univent cavity.
9. Empty trash/recycling daily to avoid the introduction of pests and spills. Consider installing tile in this area.
